Original article

Science, value and material decay in the conservation of historic environments

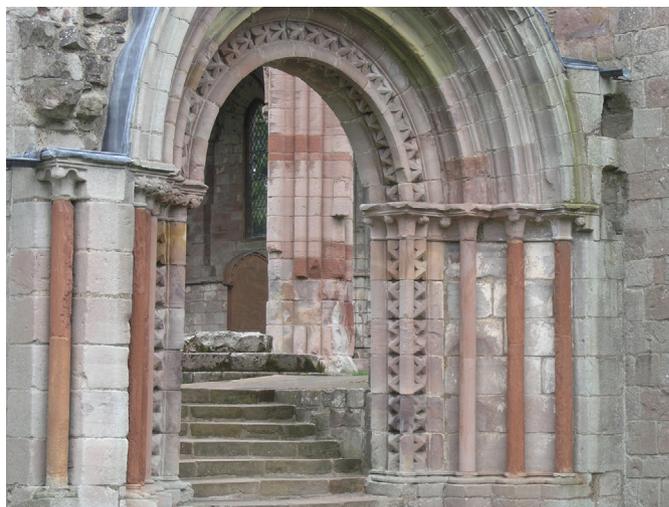
Fig. 1. Early Gothic (12–13th C) rounded arch doorway at the remains of Dryburgh Abbey, Scottish Borders. This doorway is the south entrance to the Choir, adjacent to the South Transept of the main church, and the Chapter House. The complex is composed of local white sandstone; the door is surrounded with side pillars of dark red sandstone (Photograph: Maureen Young, Historic Environment Scotland).

Dryburgh Abbey (Fig. 1) was founded in the 1150s by the Premonstratensians on a bend in the River Tweed, approximately 60 km south west of Edinburgh. It is a typical mediaeval, European religious complex, built in the gothic style using locally sourced sandstone. Its walls are >1 m thick, composed of coursed ashlar on the exteriors, and filled with lime and rubble. Internal surfaces would typically have been lime plastered, but most of this is lost now. Its post-Reformation biography was strongly influenced by David Erskine, founder of the Society of Antiquaries of Scotland, who curated it in the image of a romantic ruin in the late eighteenth century. It is a scheduled ancient monument in the care of Historic Scotland (HS) and it is open to the public throughout the year.

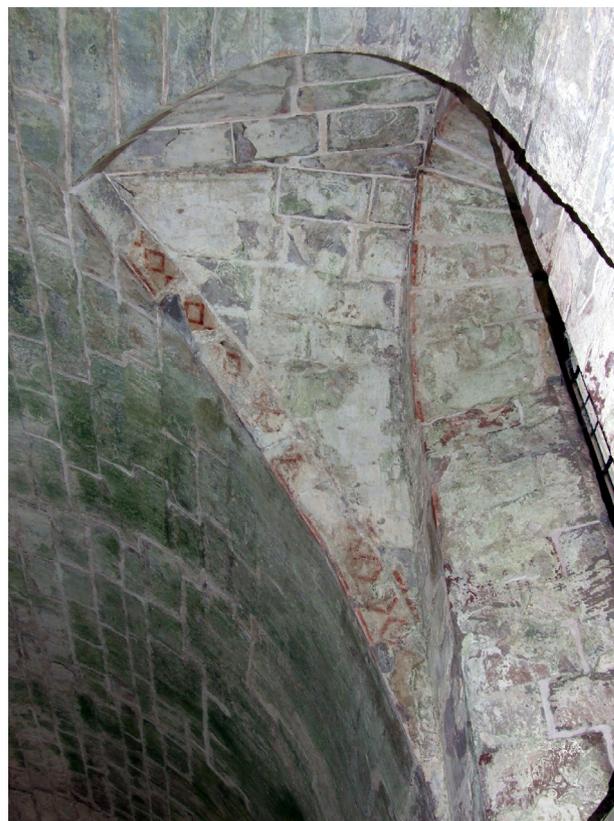
Fig. 2. Part of the mediaeval painted ceiling in the Chapter House at Dryburgh Abbey, Scottish Borders, showing details around the east-facing window. The surviving decoration is very faint. The image also clearly illustrates the greening of the stonework caused by the biological colonisation, that is the subject of periodic cleaning. The debate about the control of this surface alteration, through direct environmental control measures or cleaning, is a key conservation issue at the site (Photograph: Maureen Young, Historic Environment Scotland).

because it contains the largest area of mediaeval polychromatic wall decoration in Scotland, painted with tempera onto lime plaster (Fig. 2). However, it has been at risk for some time from water ingress from above and high air humidity. Interventions

to date have included re-roofing and waterproofing, as well as the construction of a French drain to ameliorate rising damp. The decorations and the internal walls suffer nonetheless from colonisation by algae and lichens. The ceiling and walls are currently cleaned using a weak chemical biocidal treatment. This intervention is regarded by HS as an acceptable temporary measure to control the biocolonisation, which returns requiring biannual re-application. Other interventions, such as UV irradiation of the walls, have proven to be ineffective [30].

More recent scientific research and intervention has focused on preventative conservation. Data loggers have been used to monitor the RH (>90%) and the movement of condensing air. Based on these data, the introduction of a door and window glazing has been proposed, allowing active control of humidity to discourage biological growths. To explore the possible effects of environmental modification, HS conducted an experimental trial during 2012–13 in a small room adjoining the Chapter House. The trial demonstrated that relative humidity (RH) could successfully be controlled through this method, but painting conservators, architects and site staff have expressed concerns regarding the wider impact of the intervention. These range from the potential risk of promoting salt efflorescence on the plaster itself, to compromising the atmosphere and authenticity of the Chapter House and the Abbey. At the time of our research, HS was still considering the best course of action.

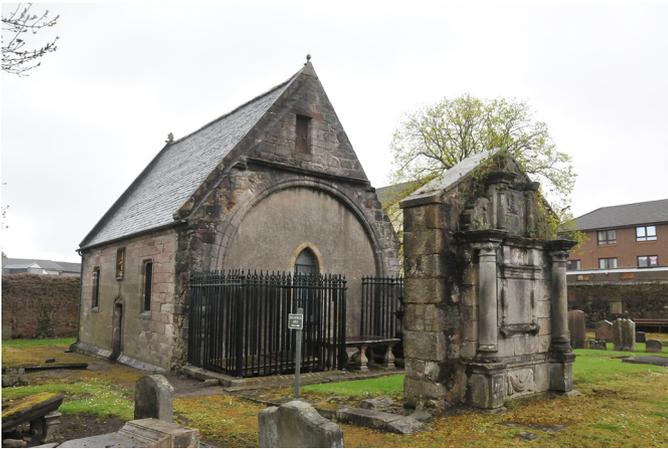
Fig. 3. Skelmorlie Aisle, Largs, East Ayrshire (1636–38), is the remaining fragment of a larger, now demolished, church. It now sits in a graveyard in the centre of Largs, enclosed by the surrounding wall and other buildings. Its highlight lies inside, the dramatically carved 17th C loft and mausoleum of the Montgomerie Family (Photograph: Maureen Young, Historic Environment Scotland).

Skelmorlie Aisle (Fig. 3) in Largs, North Ayrshire, was built in the 1630s by Sir Robert Montgomerie of Skelmorlie to provide a place for private worship and burial. Originally the north transept of Largs old church, it remained as a free-standing mausoleum structure in the historic graveyard after the rest of the church was demolished in 1802. The loft of the Montgomerie tomb within the Aisle comprises a richly carved renaissance style canopy, in dense pale gold sandstone, which is raised over a partially sunk burial vault and approached by steps with a balustraded parapet (Fig. 4). The Aisle itself has a wooden barrel-vaulted ceiling, painted with quotes from the Geneva Bible and rich allegorical landscapes by James Stalker, dating from 1638 ([31]: Fig. 5). Together the carved stone tomb canopy and the painted wooden ceiling represent perhaps the most outstanding examples of such work in Scotland. The Aisle is both a scheduled ancient monument and a Historic Scotland (HS) Property in Care. Nevertheless, visitor numbers are considerably lower than Dryburgh, in part because access is more restricted. Keys for the graveyard and the Aisle must be obtained from Largs Museum (open 2–5pm between May and September).

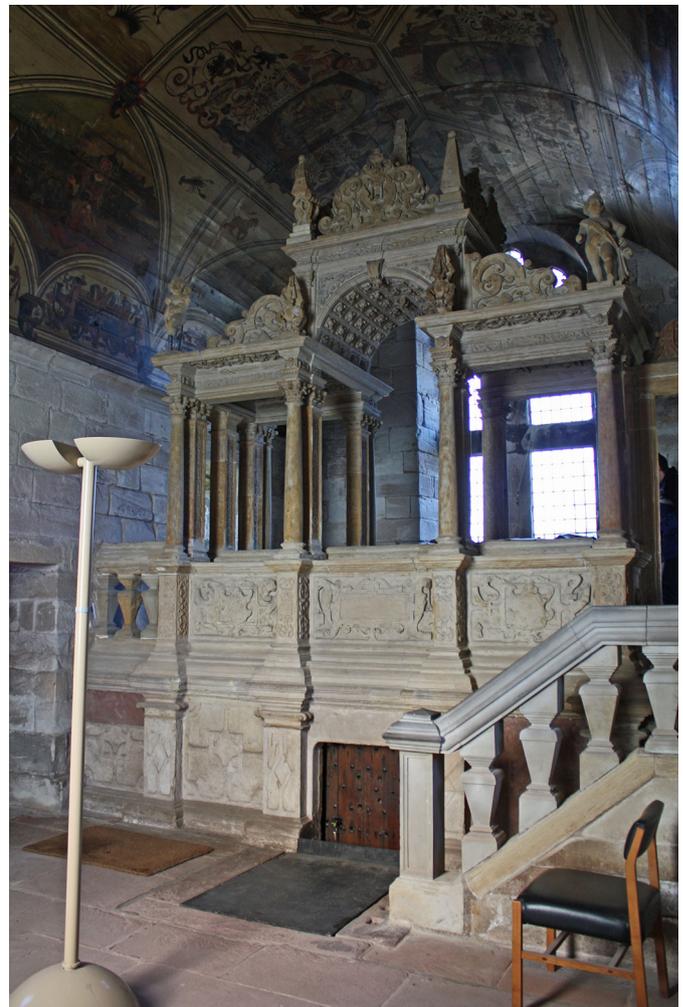
Fig. 4. The interior of the Skelmorlie Aisle. The richly carved renaissance canopy sits above the subterranean burial vault of the Montgomerie. The canopy, or loft was the private worship space of the Montgomerie. The wooden ceiling above the loft is richly illustrated (1638) with allegorical classical, biblical and landscape scenes, including one of Largs with the full church with the Aisle itself, before demolition (Photograph: Maureen Young, Historic Environment Scotland).

The ceiling paintings are in a good state of preservation. The tomb canopy is faring less well. Although the upper stonework is crisp, the lower parts appear badly decayed. Granular disintegration and exfoliation (Fig. 5) have been evident since the mid 20th century, manifesting as craters, flaking and powdering on the surface. Indeed, records show that in 1940 powdered surfaces were treated with Magnesium Fluorosilicate with little evident success. In places, a thin crust has formed, with disintegration continuing beneath. So far, the decay has been attributed to high moisture levels and possible salt contamination. There are also damp patches and salt efflorescence on the walls of the Aisle, which are constructed from course ashlar. The south wall is a particular concern, because it originally consisted of an internal wall with a pointed arch that was blocked and rendered ('harled' in Scotland) externally after the rest of the church was demolished.

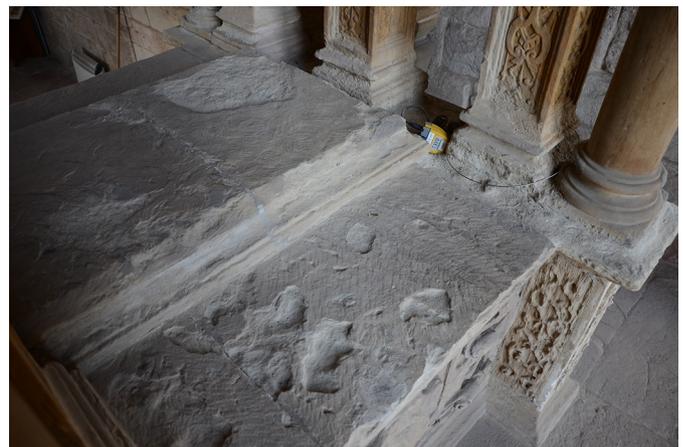
Fig. 5. Decay on the top of the tomb at the Skelmorlie Aisle, Largs. Here the dense fine-grained sandstone is suffering from cratering and powdering. At the centre top right of the image, an environmental logging device can be seen attached to the structure, recording conditions of Temperature and Relative Humidity near to where the damage is occurring (Photograph: Maureen Young, Historic Environment Scotland).

The root cause of the stone decay on the surface of the tomb structure remains a puzzle. The isolated character of the decay, and the manner in which it eludes a clear diagnosis, places conservators in long-term dialogue with material scientists, geologists and preventative conservators. Efforts to find out what has been causing the flaking of the stone demonstrate how different professionals engage with material transformation in different ways.

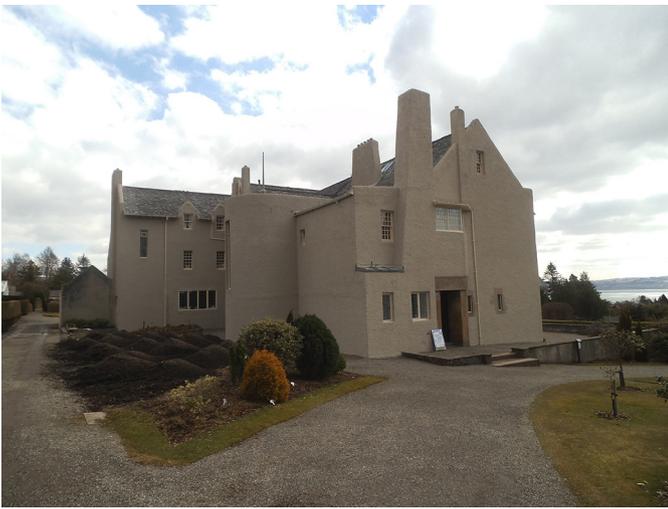
Fig. 6. The west façade and the entrance to the Hill House, Helensburgh, Argyll and Bute (C.R. Mackintosh, architect, 1904–5). This view was taken in 2013 some months after the exterior Portland Cement render had been painted to unify the appearance and improve resistance to environmental attack. The Clyde estuary can be seen in the background (Photograph: John Hughes).

The Hill House (Fig. 6) sits on an elevated, exposed, southwest-facing coastal site above the town of Helensburgh, approximately 30 km west of Glasgow. Designed and constructed during 1903–4 by the Glasgow-based architect Charles Rennie Mackintosh (1868–1928), it was commissioned by Scottish publisher Walter Blackie, as his family home. Mackintosh was a modern architect with a distinctive style variously associated with the Arts and Crafts, Art Nouveau and European secessionist movements. He is also known for design and furnishing of the interior of his buildings, in partnership with his wife Margaret Macdonald, as was the case at Hill House. Mackintosh’s status has increased significantly in recent decades, meaning that his surviving work now attracts the highest levels of statutory protection. The Hill House was designated a Category A Listed Building in 1971 and donated to the National Trust for Scotland (NTS) in 1982. It has a resident property manager, and is open to the public between April and October.

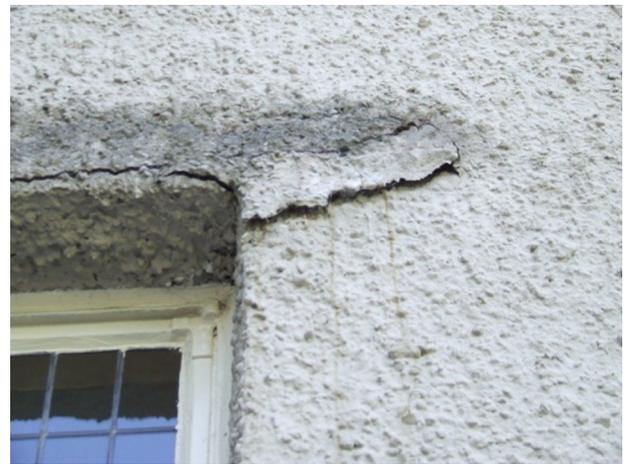
Fig. 7. Example of the cracking in the Portland Cement render of the Hill House, Helensburgh. Cracking such as this allows water ingress that threatens the historic Macintosh-Macdonald designed interior decoration and furniture (Photograph: John Hughes).

Mackintosh was keen to apply new materials in his buildings. Whilst the Hill House has solid masonry walls made from brick and soft red sandstone, the exterior is rendered in grey-coloured roughcast render, or “harl”, containing Portland Cement (PC). At the time, PC had gained currency and was promoted as the strongest, most waterproof material available [32]. This claim persuaded

Mackintosh to use it in his pursuit of novel, modern design values, allowing him to dispense with traditional water-shedding features, such as wall copes at gables and window cills. However, the inflexibility of the PC-based render, compared with a lime-based alternative, has resulted in extensive cracking (Fig. 7). PC’s low water permeability and high capillary retention traps any water ingress that occurs through the cracks causing further deterioration of the render, exacerbated by freeze-thaw action. In places, moisture has penetrated the whole wall, putting the Mackintosh-Macdonald interior at risk by increasing RH and condensation, resulting in mould growth. There have also been outbreaks of dry rot. Recent scientific investigations have focused on investigating the condition of the fabric of the building using materials analysis (petrographic thin sections and XRD) and thermography, alongside traditional engineering and condition surveying. The internal environment is being monitored with Hanwell recorders documenting temperature and RH in several rooms.

The NTS are in the process of examining the history of repairs and the scope of possible future interventions ([32]). Their deliberations centre on the status of the render, particularly the extent of original fabric remaining, and the technical repair challenges posed by previous interventions. In terms of conservation philosophy, there are questions regarding authenticity and whether this lies in the original fabric, or in the other aspects, such as the building’s design and Mackintosh’s intentions. During the 1980s, a hydrophobic silane was used with limited success, both as a surface water repellent coating and as a consolidant in conjunction with carbon rod ties in the interface between the PC harl and the degrading underlying sandstone ([32]: section 3.1). Current thinking questions the appropriateness of this former conservation strategy, since it used an irreversible experimental approach to preserve the fabric through introduction of a different manufactured material ([32]: 75). There are also concerns about whether the use of the silane consolidant has exacerbated problems with the harl, leading to further problems of water retention. Evidence now suggests that a considerable amount of the original render had in fact already been replaced during the Hill House’s life cycle, perhaps as much as 80%.
